Windstorm Mitigation Report (OIR-B1-1802)

The Woods At Anderson Park Condominium Association, Inc.
39650 Us Hwy 19 N, Building 58, Units 581-584
Tarpon Springs, FL 34689

As of 5/14/2021 | FPAT File# MUD2116015

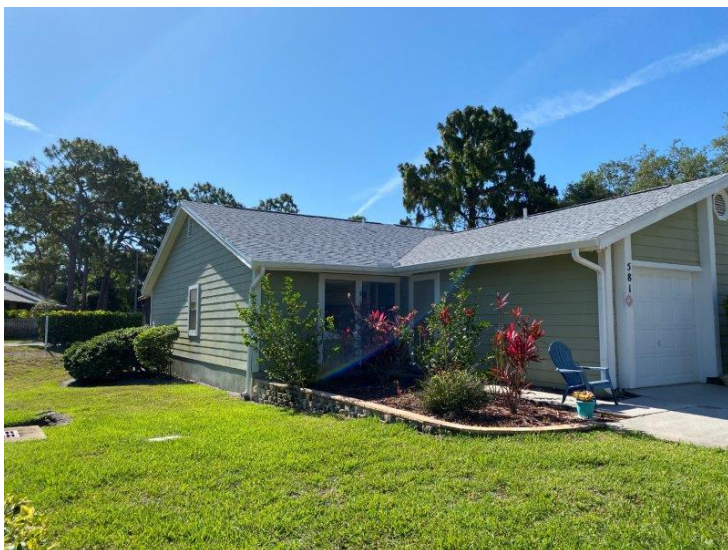
Exterior Elevation

- 4. Roof to Wall Attachment:** **Clips**
Comments: Inspection verified hurricane clips fastened with a minimum of three nails.
- 5. Roof Geometry:** **Other Roof**
Comments: Inspection verified a gable roof shape.

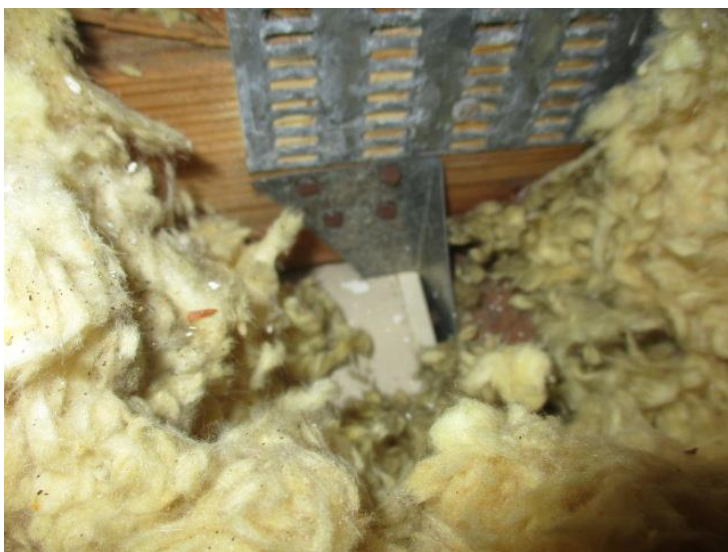
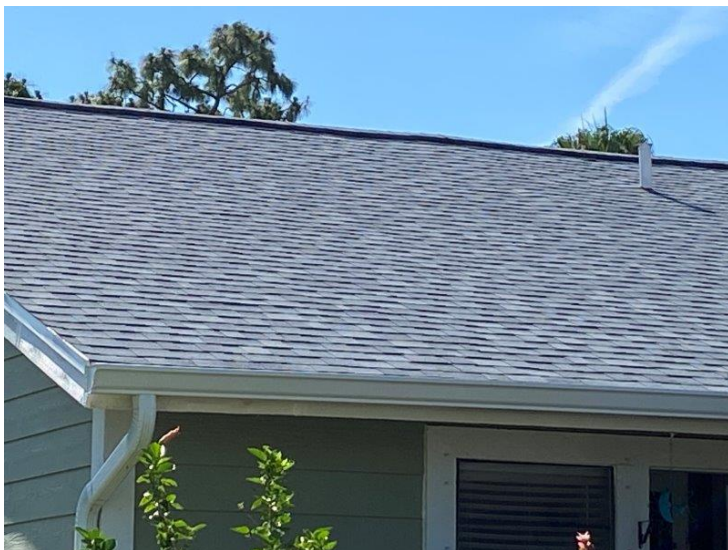
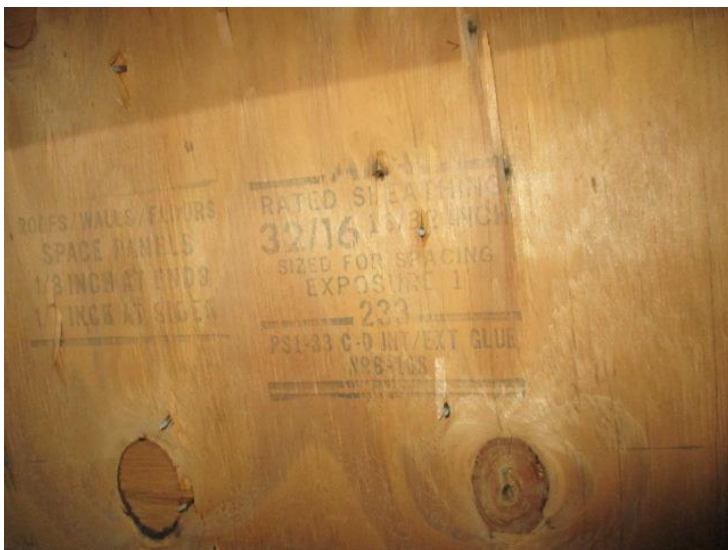
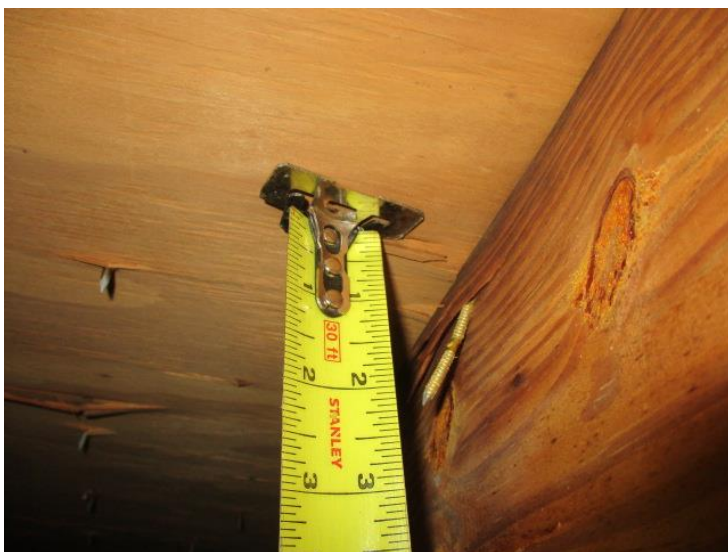
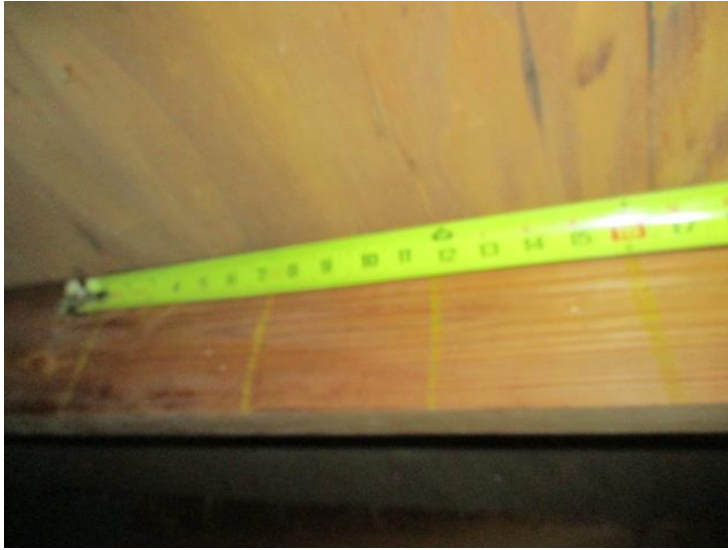
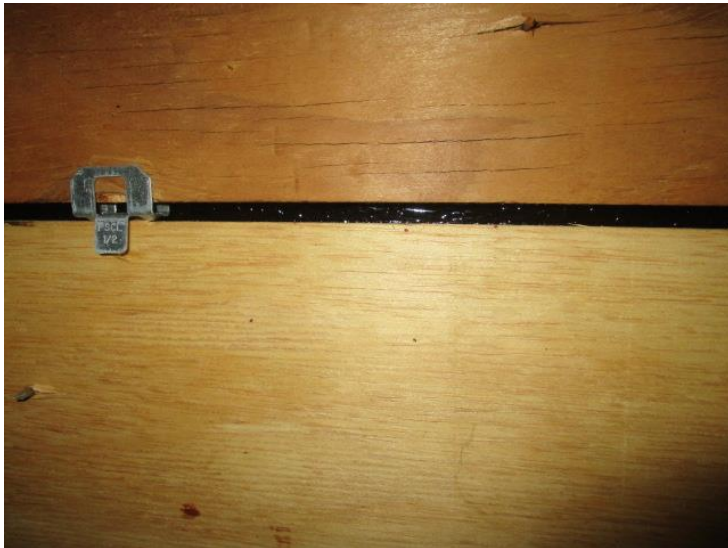
Roof Construction

- 3. Roof Deck Attachment:** **Level C**
Comments: Inspection verified 1/2" plywood roof deck attached with 8d nails at a minimum 6" on the edge & 6" in the field.

- 6. SWR:** **Yes**
Comments: SWR was verified at time of inspection. The Secondary Water Resistance verified is a self-adhering peel and stick.
- 7. Opening Protection:** **None or Some Glazed Openings**
Comments: No opening protection verified at the time of inspection.
