Windstorm Mitigation Report (OIR-B1-1802)

The Woods At Anderson Park Condominium Association, Inc.

39650 US 19 N, Bldg 32, Units 321-326

As of 4/5/2023 | FPAT File# MUD2319413

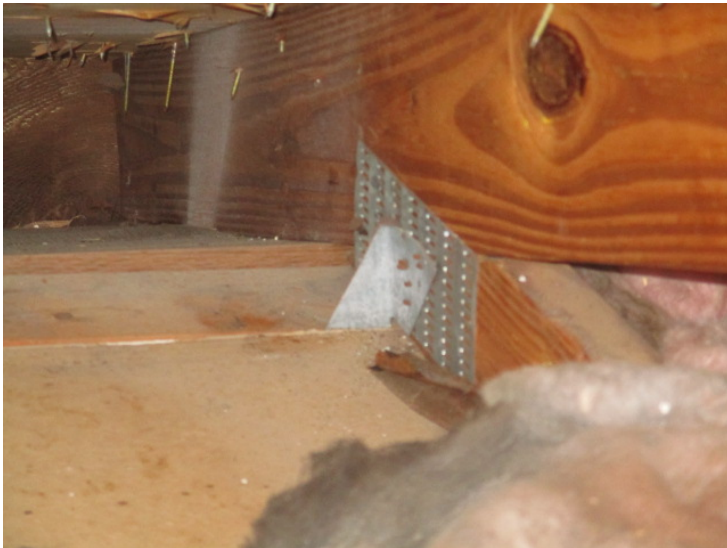
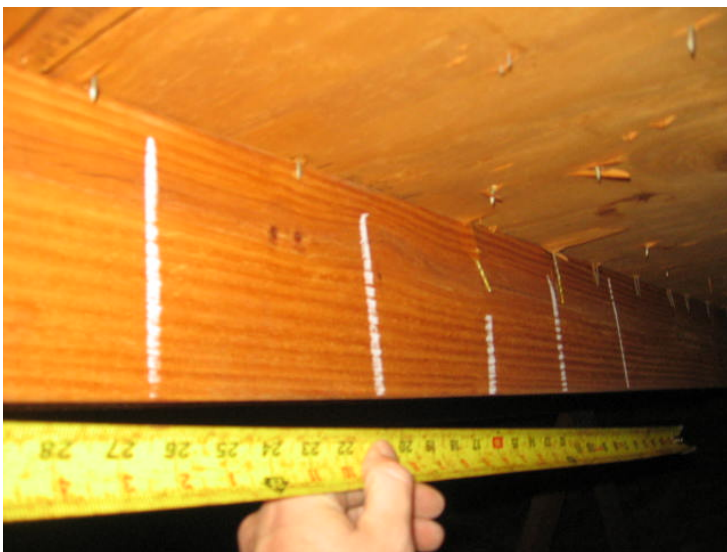
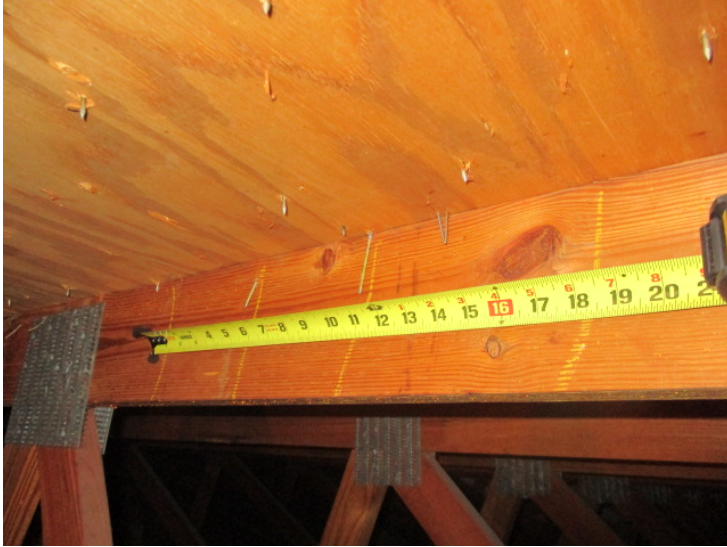
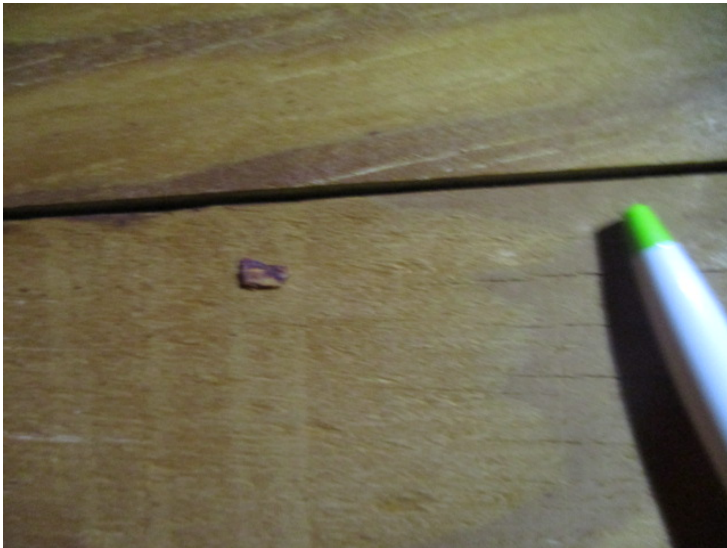
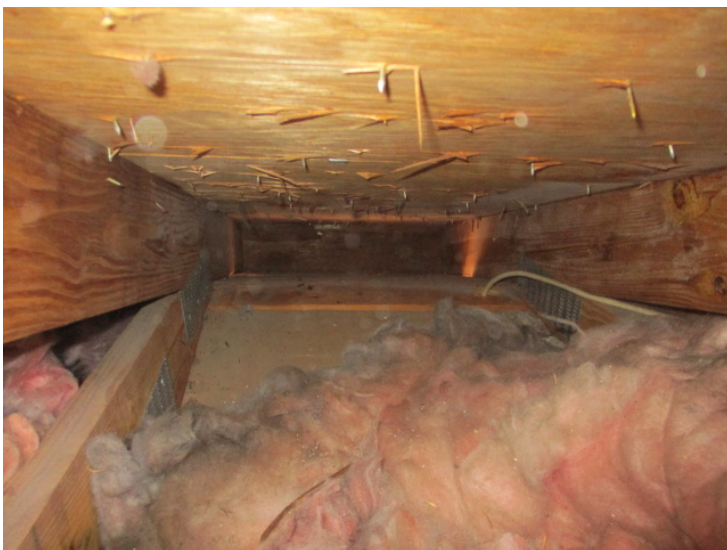
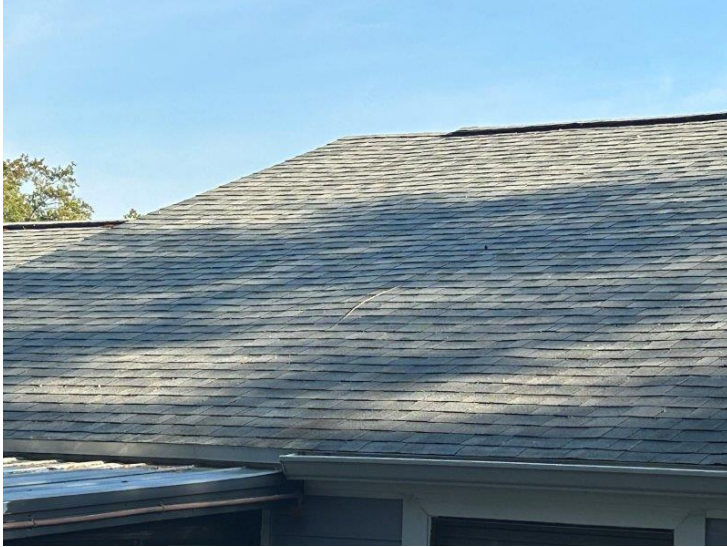
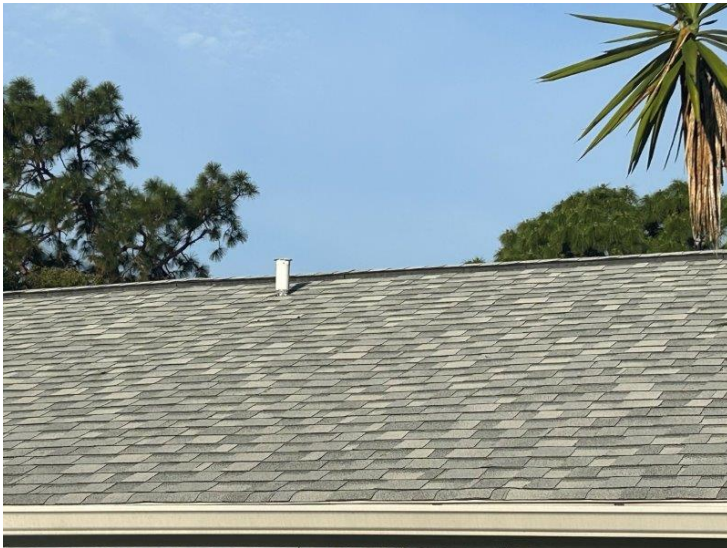
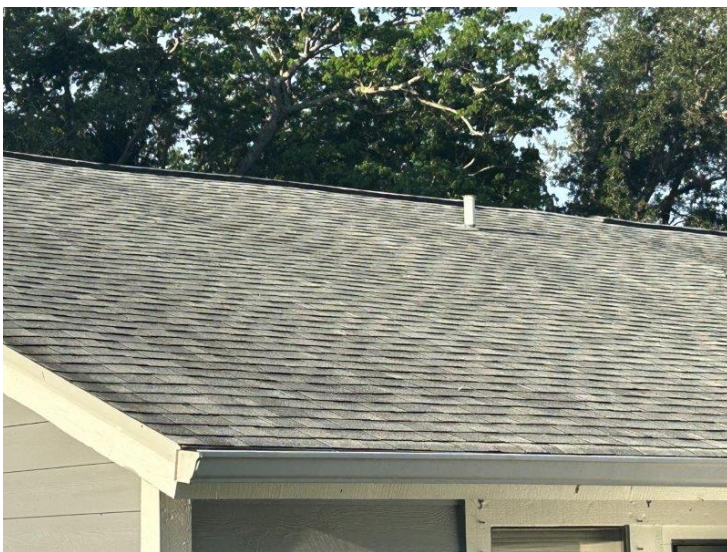
Roof Construction

- 3. Roof Deck Attachment:** **Level C**
Comments: Inspection verified 1/2" plywood roof deck attached with 8d nails at a minimum 6" on the edge & 6" in the field.

- 4. Roof to Wall Attachment:** **Clips**
Comments: Inspection verified hurricane clips fastened with a minimum of three nails.
- 5. Roof Geometry:** **Other Roof**
Comments: Inspection verified a gable roof shape.

- 6. SWR:** **Yes**
Comments: SWR was verified at time of inspection. The Secondary Water Resistance verified is a self-adhering peel and stick.
- 7. Opening Protection:** **None or Some Glazed Openings**
Comments: No opening protection verified at the time of inspection.

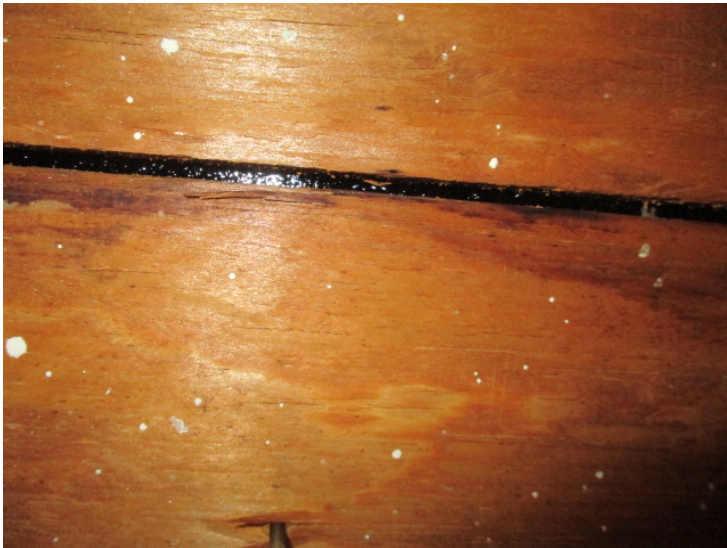
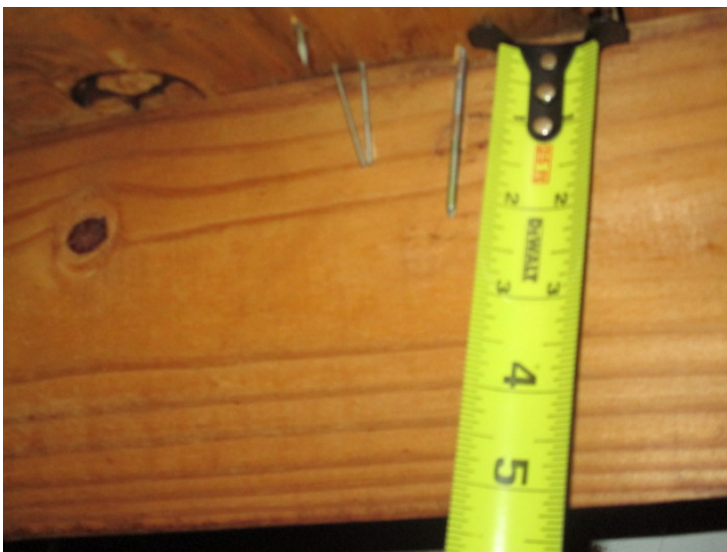
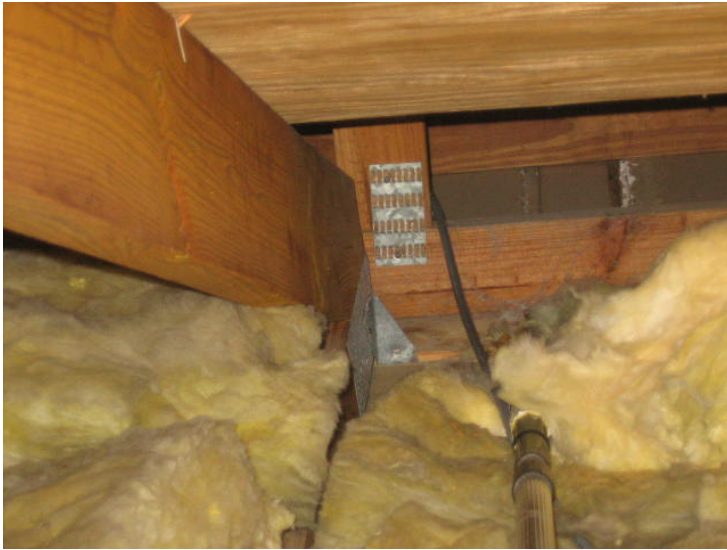
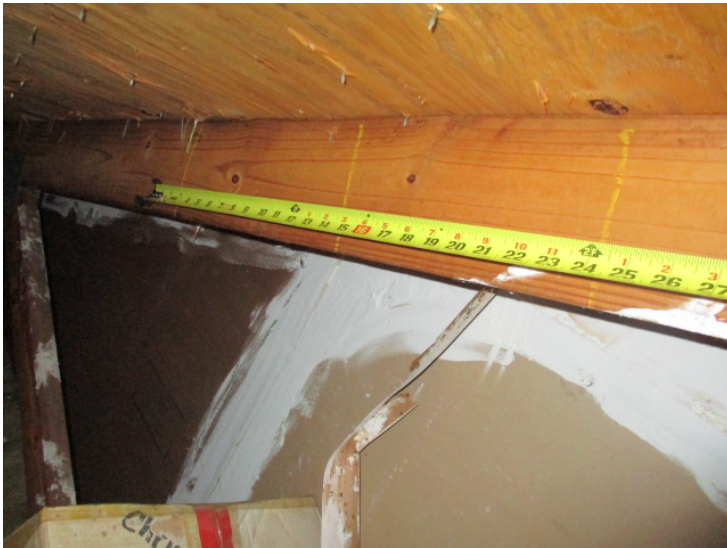
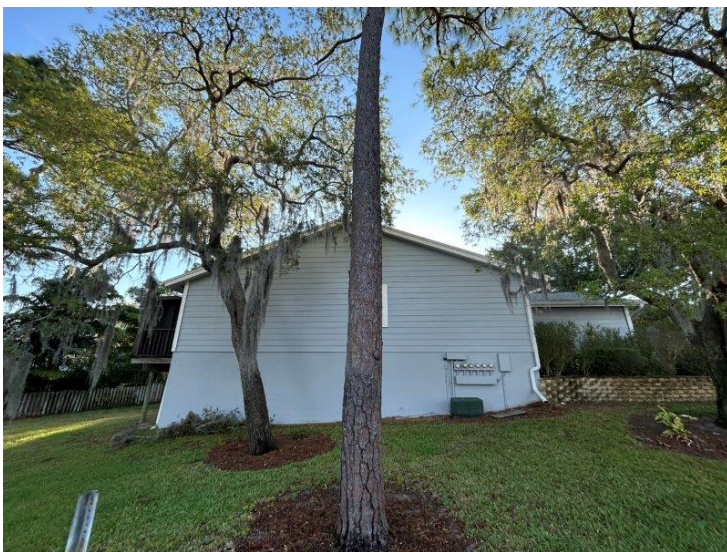
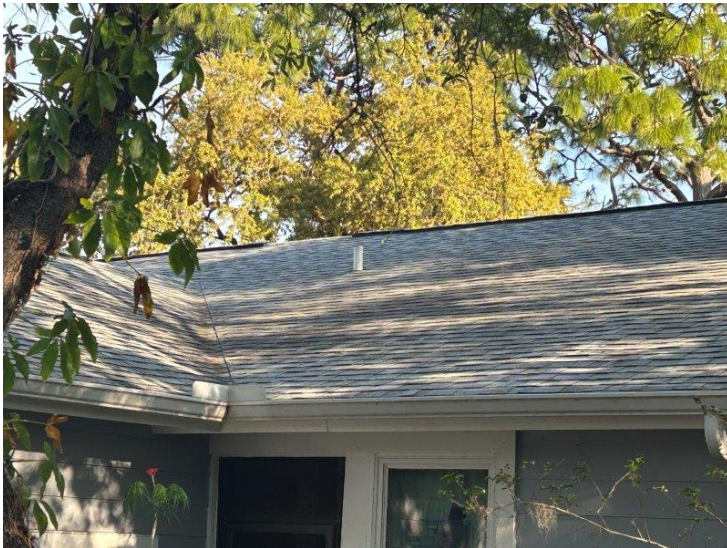
Roof Construction

- 3. Roof Deck Attachment:** **Level C**
Comments: Inspection verified 1/2" plywood roof deck attached with 8d nails at a minimum 6" on the edge & 6" in the field.

- 4. Roof to Wall Attachment:** **Clips**
Comments: Inspection verified hurricane clips fastened with a minimum of three nails.
- 5. Roof Geometry:** **Other Roof**
Comments: Inspection verified a gable roof shape.

- 6. SWR:** **Yes**
Comments: SWR was verified at time of inspection. The Secondary Water Resistance verified is a self-adhering peel and stick.
- 7. Opening Protection:** **None or Some Glazed Openings**
Comments: No opening protection verified at the time of inspection.

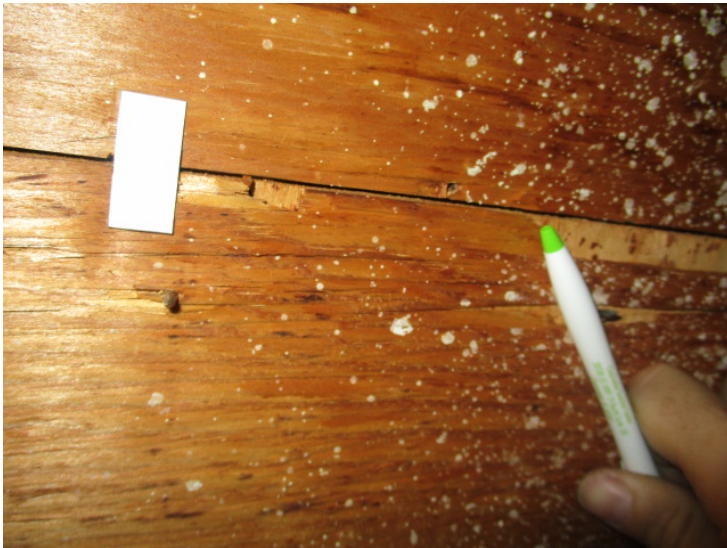
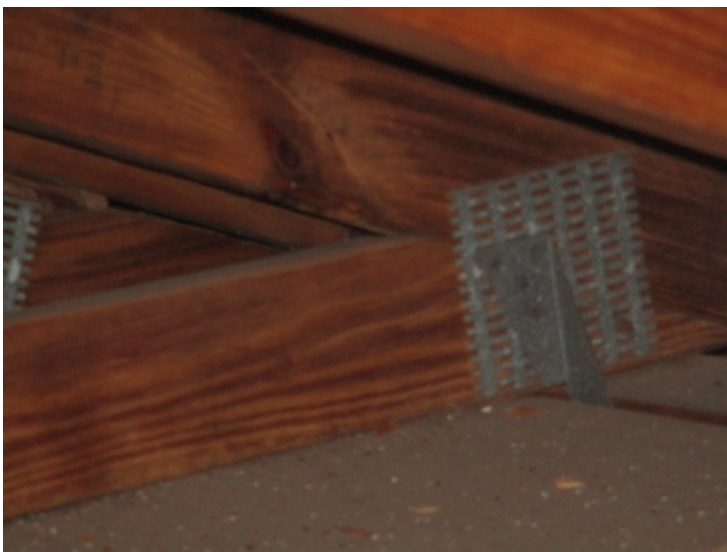
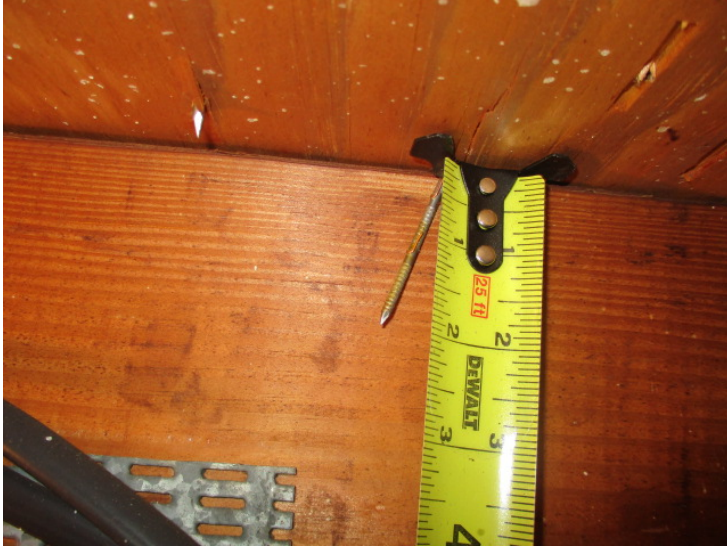
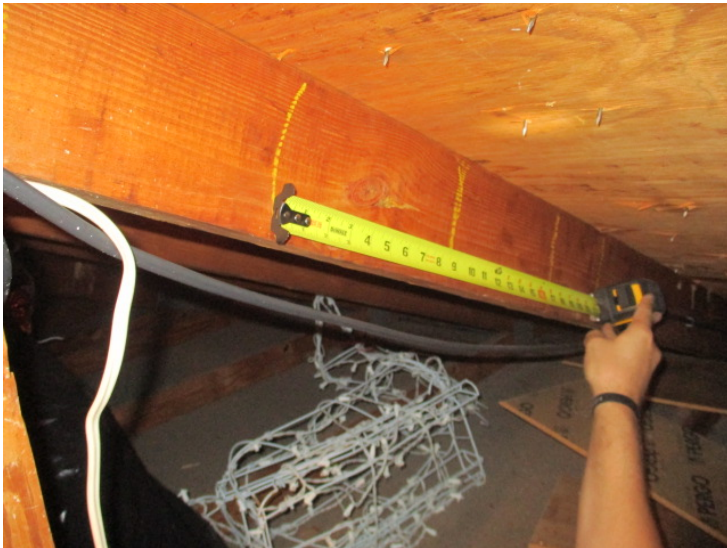
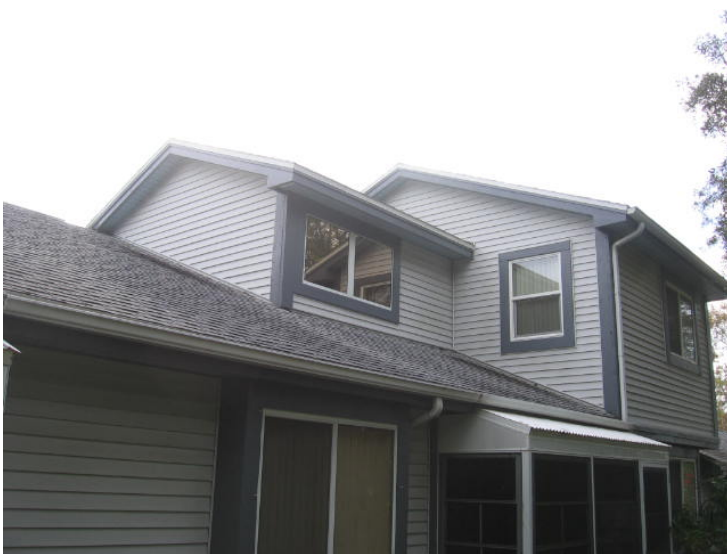
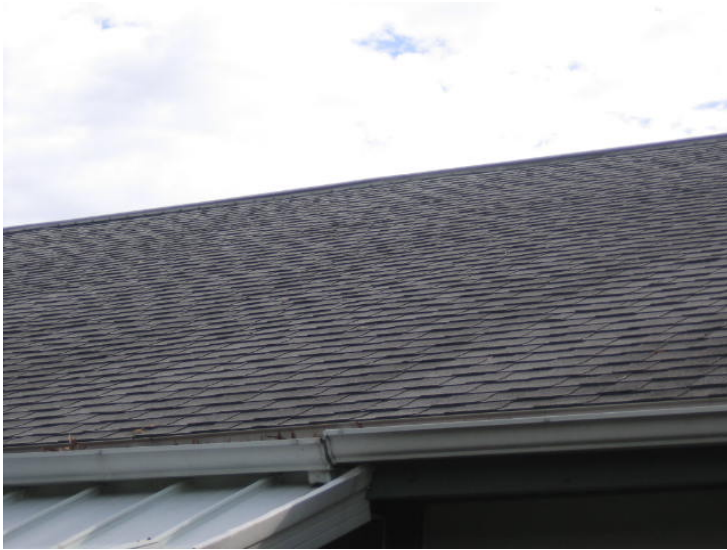
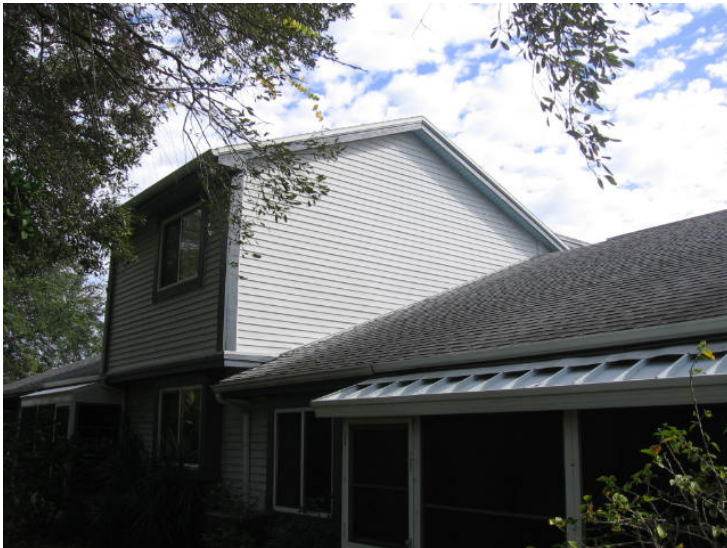
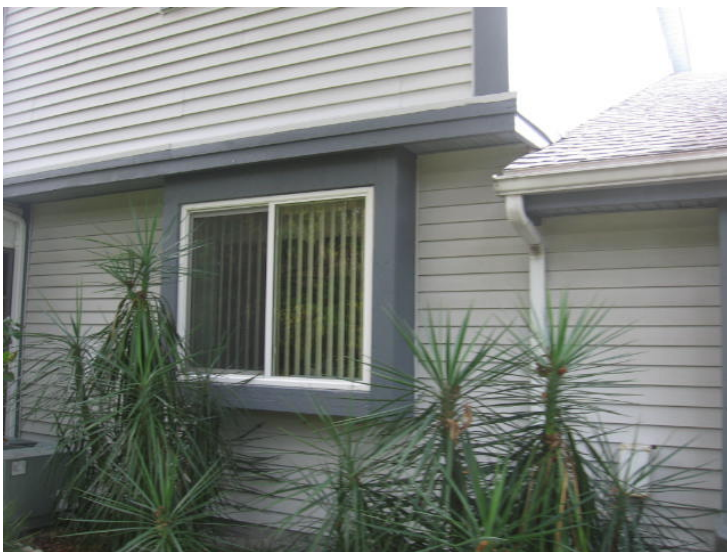
Roof Construction

- 4. Roof to Wall Attachment:** **Clips**
Comments: Inspection verified hurricane clips fastened with a minimum of three nails.
- 5. Roof Geometry:** **Other Roof**
Comments: Inspection verified a gable roof shape.

- 6. SWR:** **Yes**
Comments: SWR was verified at time of inspection. The Secondary Water Resistance verified is a self-adhering peel and stick.
- 7. Opening Protection:** **None or Some Glazed Openings**
Comments: No opening protection verified at the time of inspection.
